THERMOMECHANICAL FATIGUE
CHARACTERIZATION OF AN ANGLE PLY
METAL MATRIX COMPOSITE

THESIS

Wade H. Vaught, First Lieutenant, USAF

**In Partial Fulfillment of the
Requirements for the Degree of
Master of Science in Aeronautical Engineering**

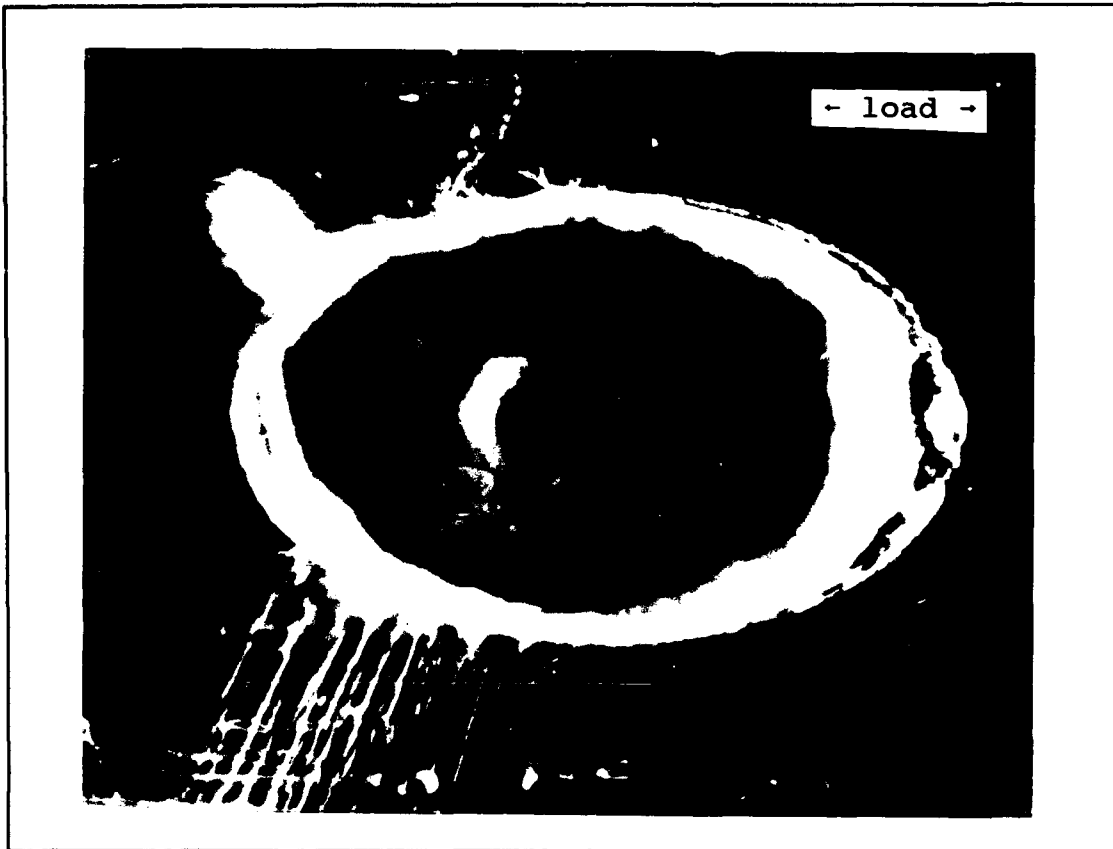
Figure 38. Edge Replica with Transverse Matrix Cracking

Edge replicas reveal that fiber-matrix interface failures were the first damage to occur, followed by transverse microcracking initiating at the reaction zone and matrix deformation around debonded fibers. Evidence of fiber

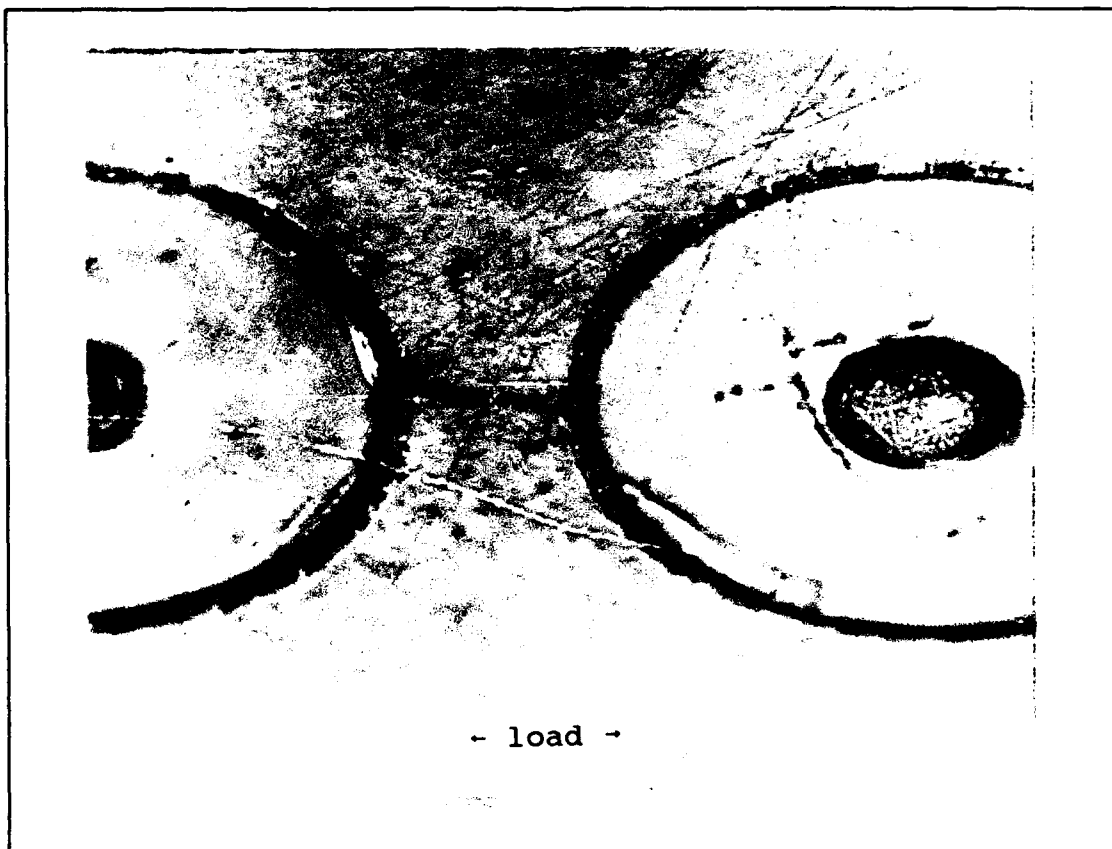
Figure 39. Edge Replica with Longitudinal Matrix Crack

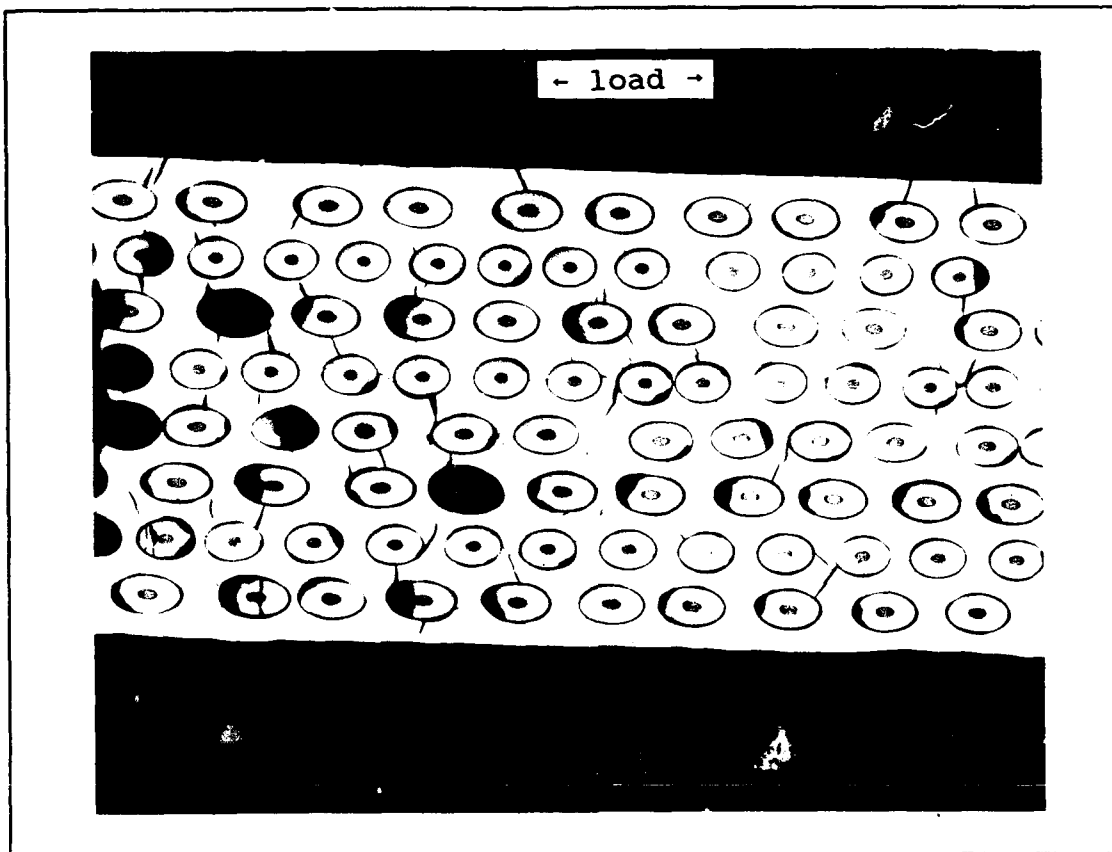
Figure 41. Typical Transverse Matrix Cracking (32x)

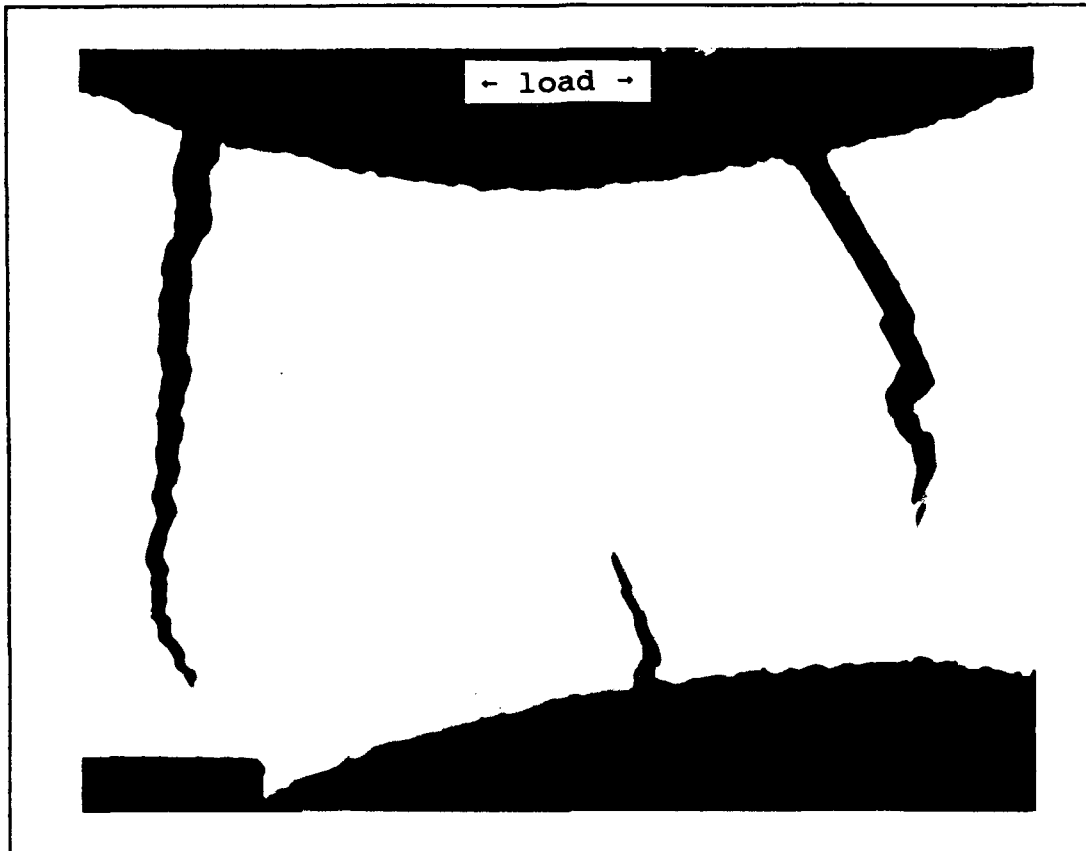
Figure 42 shows in detail transverse cracks growing from

Figure 42. Typical Transverse Matrix Cracks Emanating from Damaged Reaction Zones (1000x)

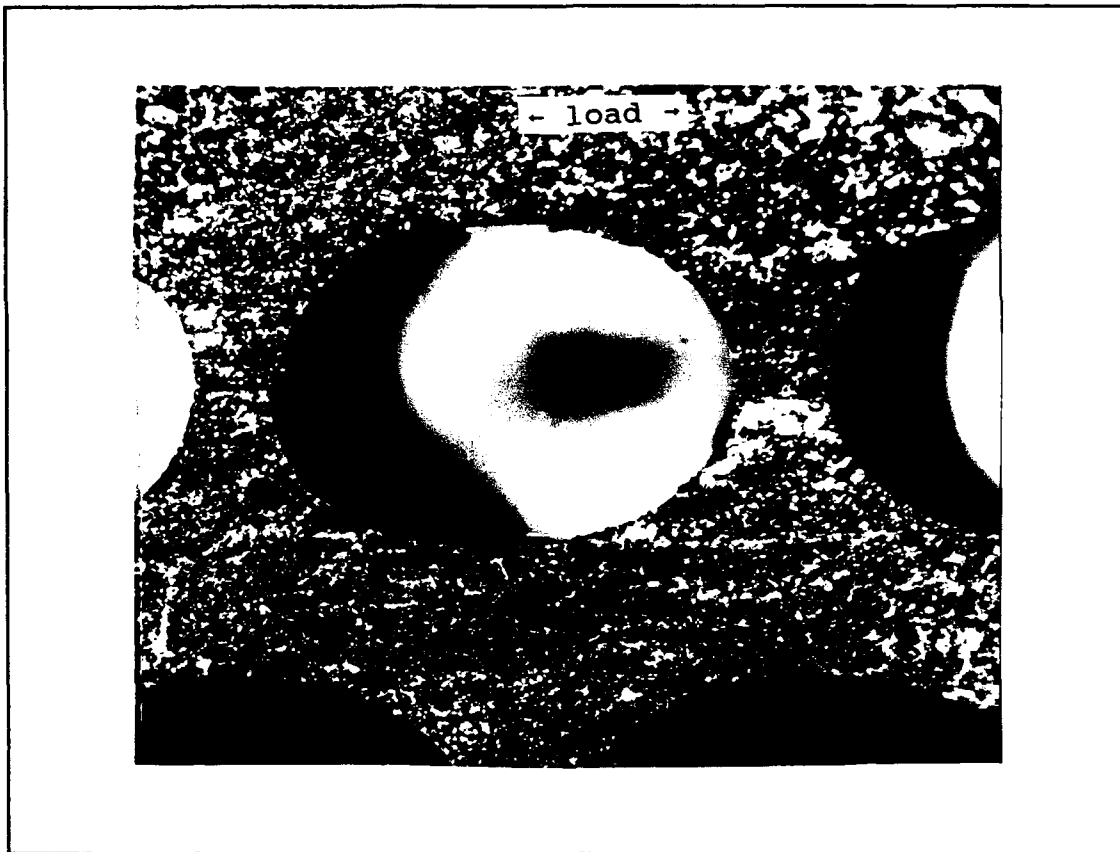
Figure 43. Typical Longitudinal Matrix Cracking along a Ply Boundary (300x)

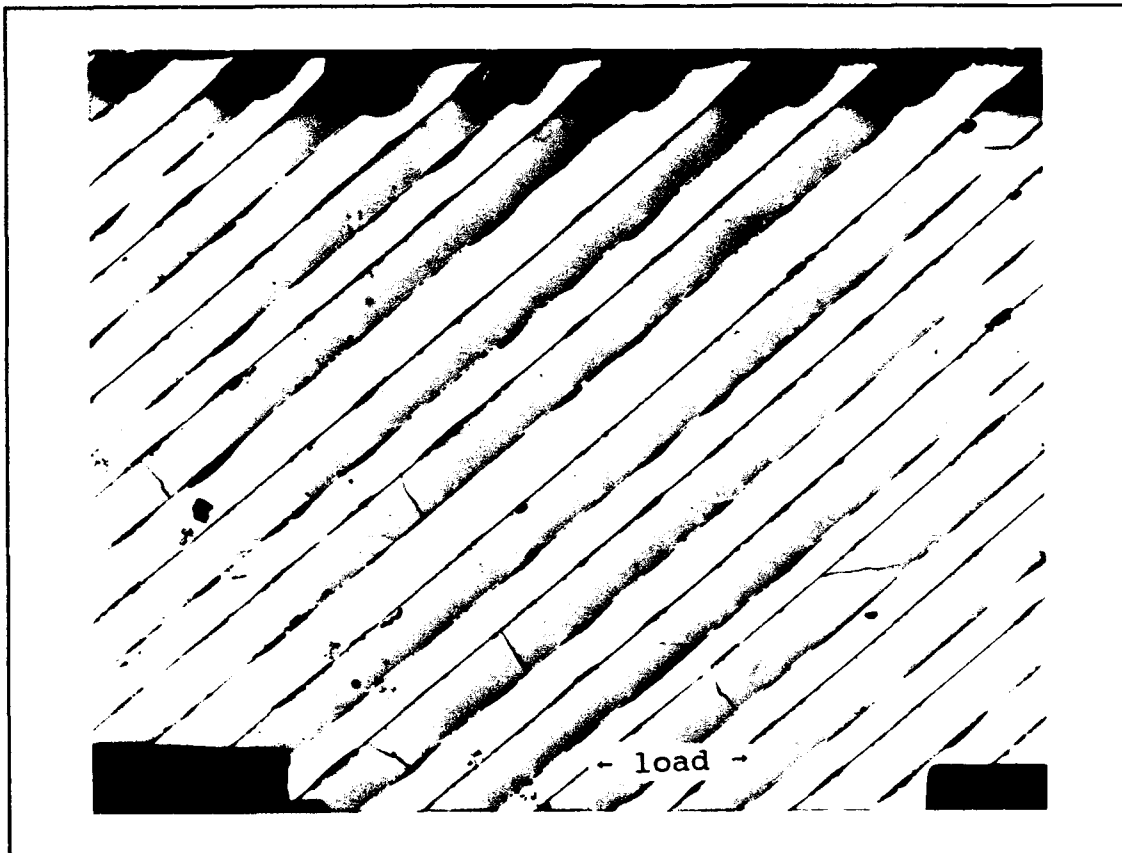
common throughout the gauge length. Figure 44 shows typical fiber cracking from the 400 MPa test specimen near the fracture. Matrix necking where debonding and high stresses led to matrix plasticity, is seen between every fiber. The fibers pulling into the laminate along the edge is also shown in the figure. Figure 45 shows the matrix necking and debonding and an associated fiber crack near the fracture in greater detail. Notice that the crack occurs along the molybdenum crossweave line and that deformation in the matrix is restricted by the crossweave next to the fiber.

Figure 44. Typical Fiber Cracking (50x)

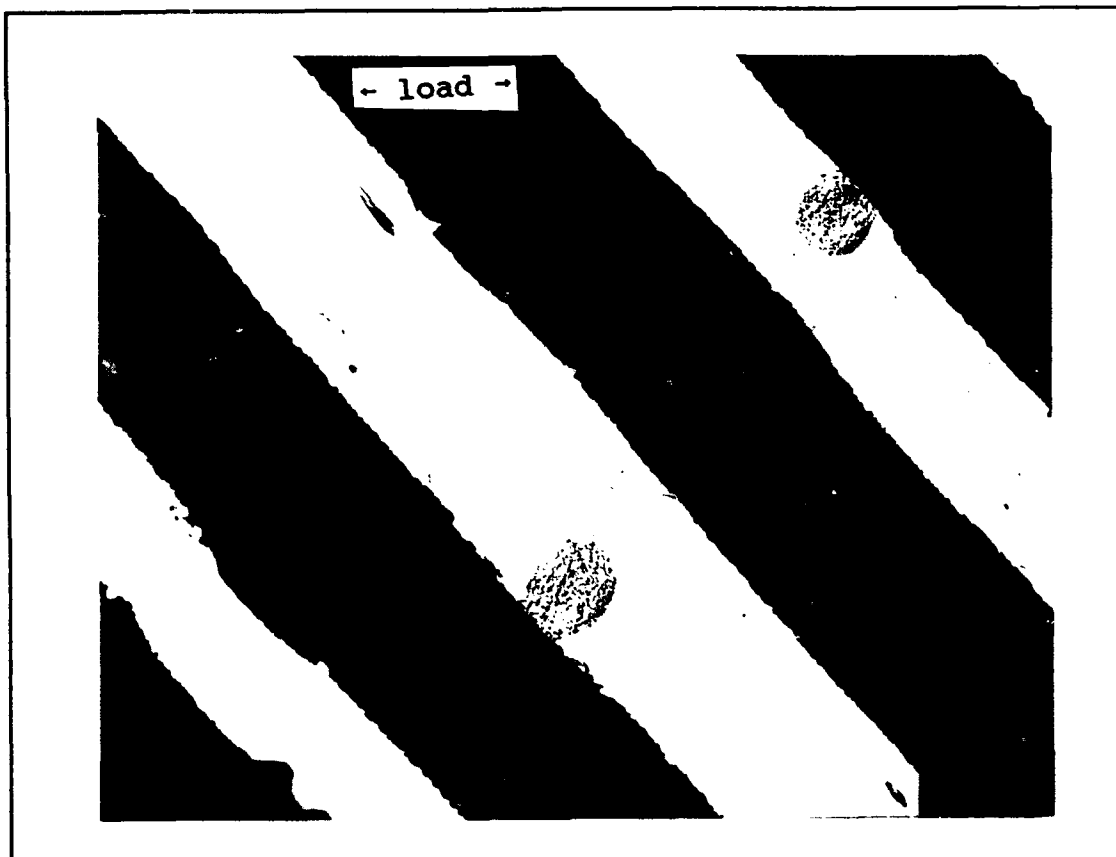
Figure 45. Typical Matrix Necking along Debonded Fibers
(200x)

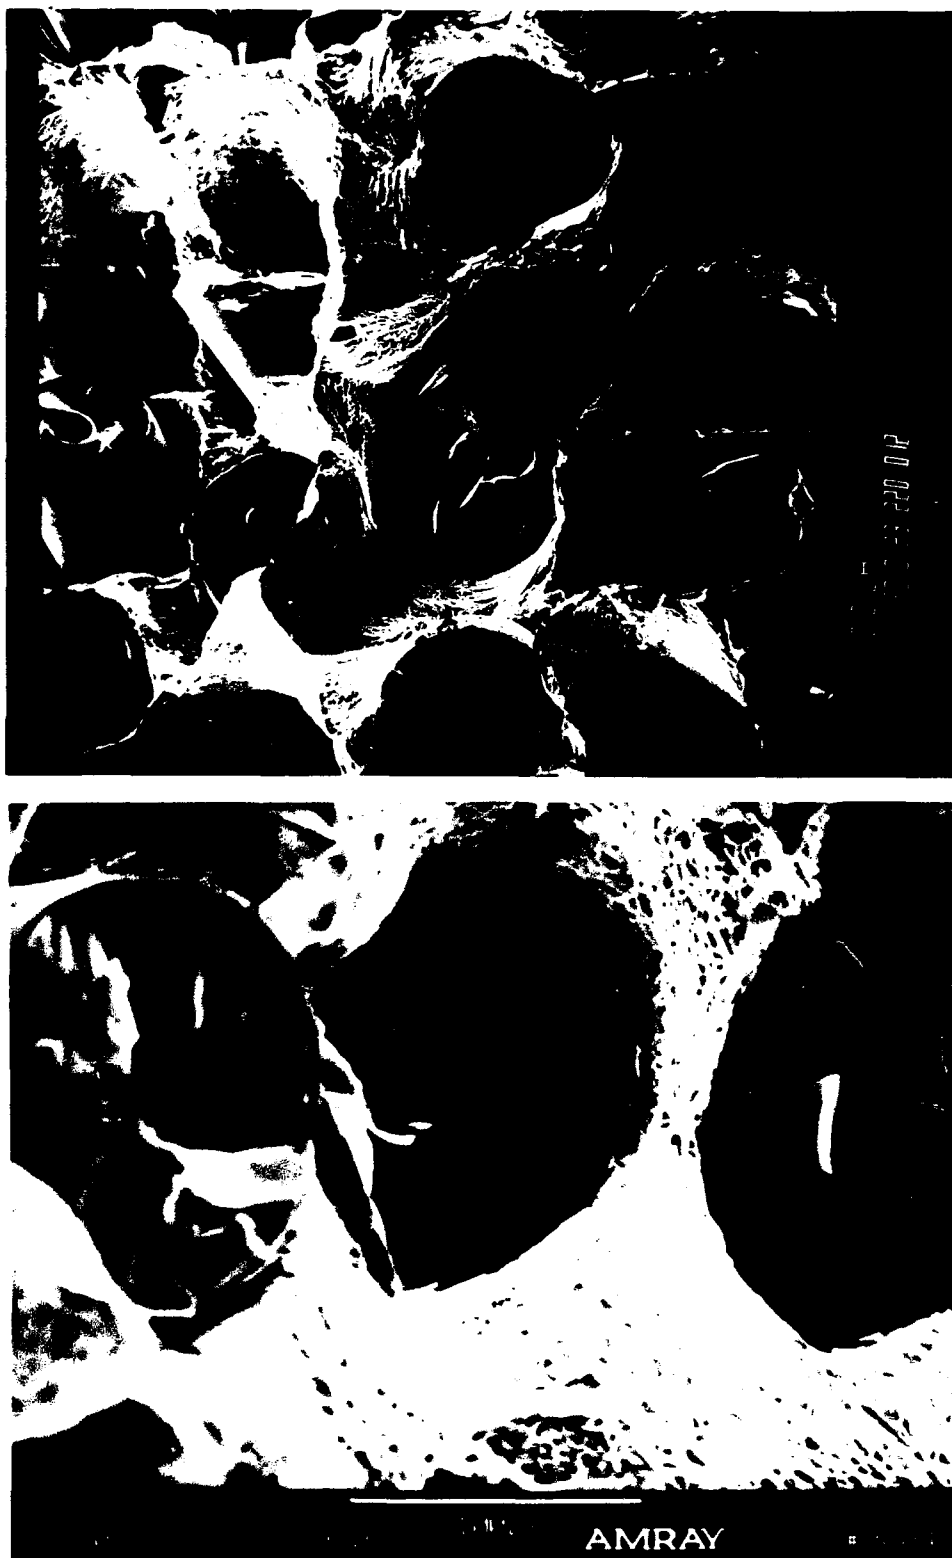
SEM analysis of the fracture surface revealed distinct fracture regions which corresponded to the dull and bright regions on the surface. The 450 MPa, 400 MPa and 350 MPa specimens contained these two regions. For these specimens, the outer edges were dull, similar to the IF fracture surface. SEM examination revealed fracture characteristics identical to those seen for tensile overload in the IF specimen. Fiber pullout and dimpled shear lips between

fibers characterize the ductile failure in this region. Figure 48 shows typical ductile regions in the 450 MPa and 400 MPa specimens. The bright mid-region made up the majority of the fracture surface for these three specimens. The fracture here is drastically different than the ductile fracture on the edges. The surface is characterized by a crystallographic cleavage fracture between fibers. Cleavage occurs due to breaking of atomic bonds along a preferred crystallographic plane and is associated with a brittle fracture containing relatively flat and reflective surfaces.

Figure 48. Typical Ductile Fracture Surfaces from the 450 MPa (top) and 400 MPa (bottom) Test Specimens

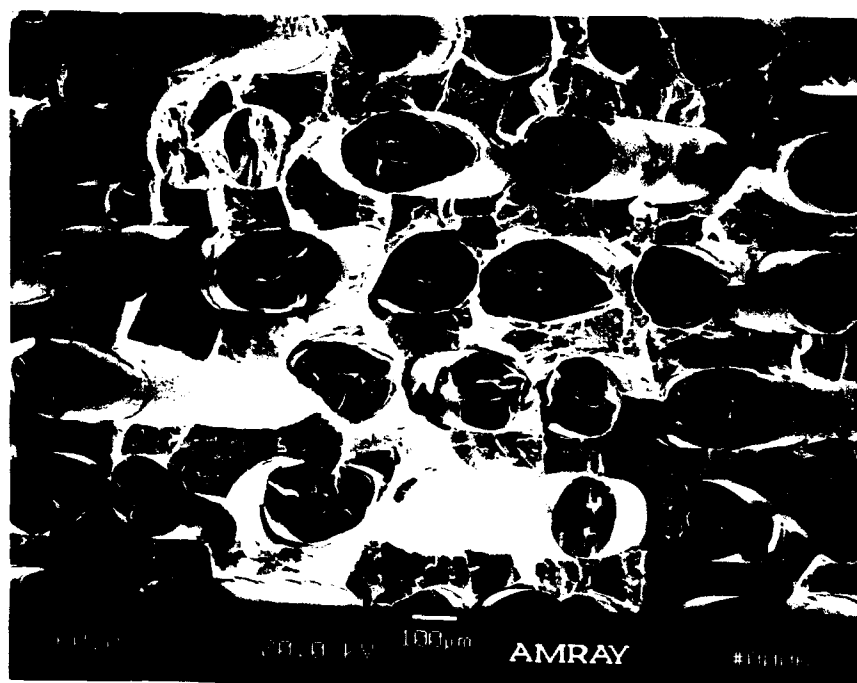
There are no shear lips or indications of plastic dimpling. on the fracture surface. This indicates a brittle fracture likely caused by fatigue crack growth. Figure 49 shows typical cleavage fracture regions in the 450 MPa and the 320 MPa specimens. Fiber pullout is seen, but not to the extent as occurred in the ductile regions. Debonding, deformation of the matrix around fibers and degradation of the fiber carbon coating was also observed. The two fracture regions in the 450 MPa, 400 MPa and 350 MPa specimens were very distinct and there was no mixing of brittle and ductile

Figure 49. Typical Cleavage Fracture Surfaces from the 450 MPa (top) and 320 MPa (bottom) Test Specimens

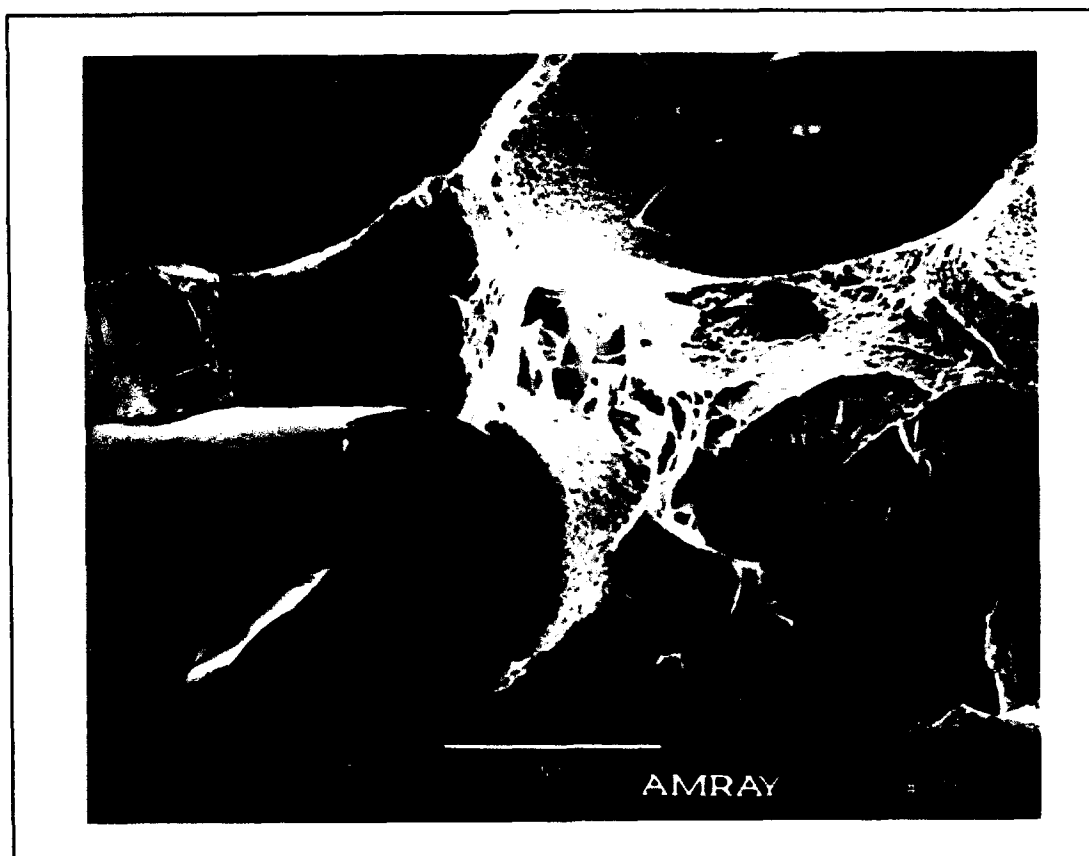
modes. The 320 MPa specimen, however, did show mixed regions of both ductile and brittle fracture. The fracture surface was dominated by cleavage fracture and did not exhibit a distinct tensile overload region. This specimen had the longest fatigue life and consequently its fracture surface exhibited the most fatigue crack growth damage. Figure 50 shows the mixed ductile and brittle regions in this specimen.

Figure 50. Fracture Surface with Mixed Brittle and Ductile Failure Regions

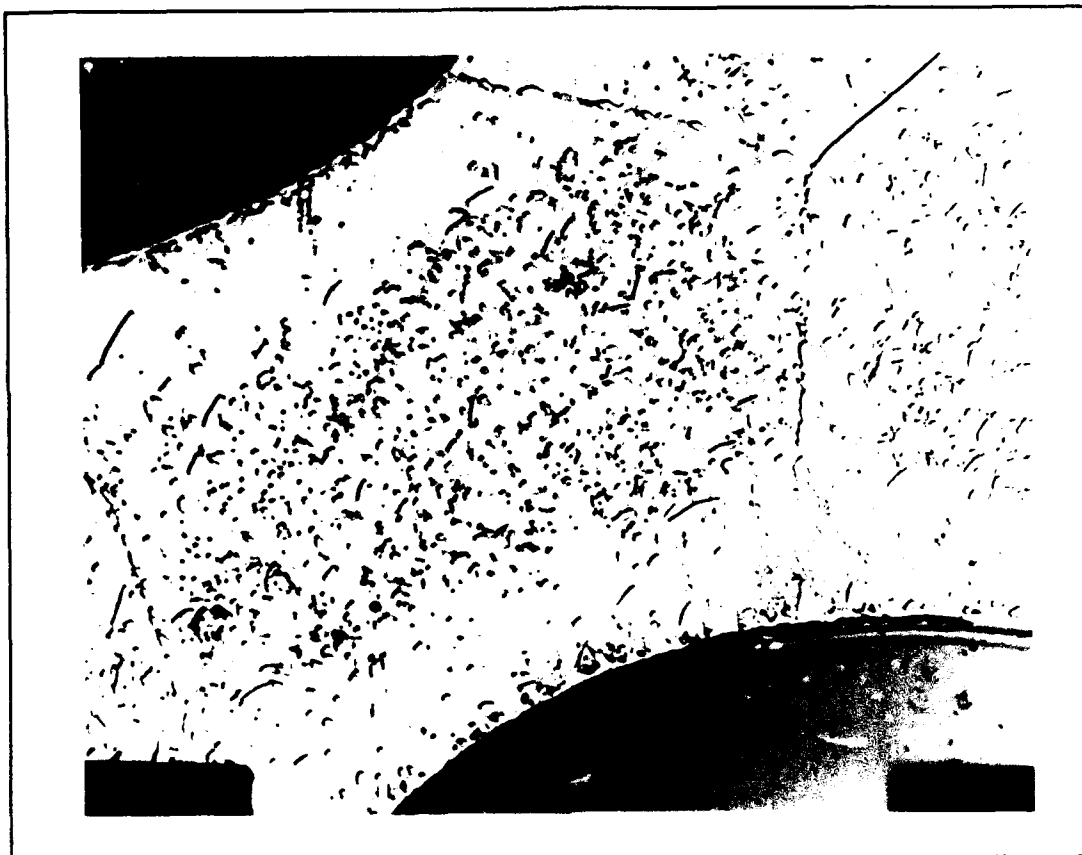
immediately surrounding the fibers and between fibers spaced too closely together. A different and more numerous type of precipitate was observed in the tested specimens. Besides the large α -Ti needles, a finer precipitate also seemed to be present. The small precipitate was especially common along ply boundaries between closely spaced fibers. The apparent finer precipitates suggested continued beta transformation during testing due to the cycling stress or temperature, or some combined effect. Figure 51 shows the microstructure after etching between two fibers in the 320 MPa test specimen after failure; note the precipitate lean zones surrounding the fibers and the slip bands in the matrix. It was not clear, however, if the precipitates were present before testing, were merely an optical illusion caused by pitting of the matrix by the etchant or were indeed additional precipitates. To further investigate the precipitation phenomenon and mechanisms, an additional experiment was conducted during which a specimen was thermally fatigued for 3200 cycles. The modulus increase observed in TMF test specimens occurred over the same range of cycles. The test conditions were identical to the TMF cycle except the tensile load was held constant at five Newtons. The objective was to determine if any stiffening of the laminate occurred during thermal cycling due to continued β -transformation. Schubbe observed an increase in modulus in an as-received $[0/90]_{2s}$ SCS-6/Ti-15-3 laminate after 10,000 thermal cycles (26:52). During thermal cycling

Figure 51. Matrix Microstructure after TMF Testing
(750x)

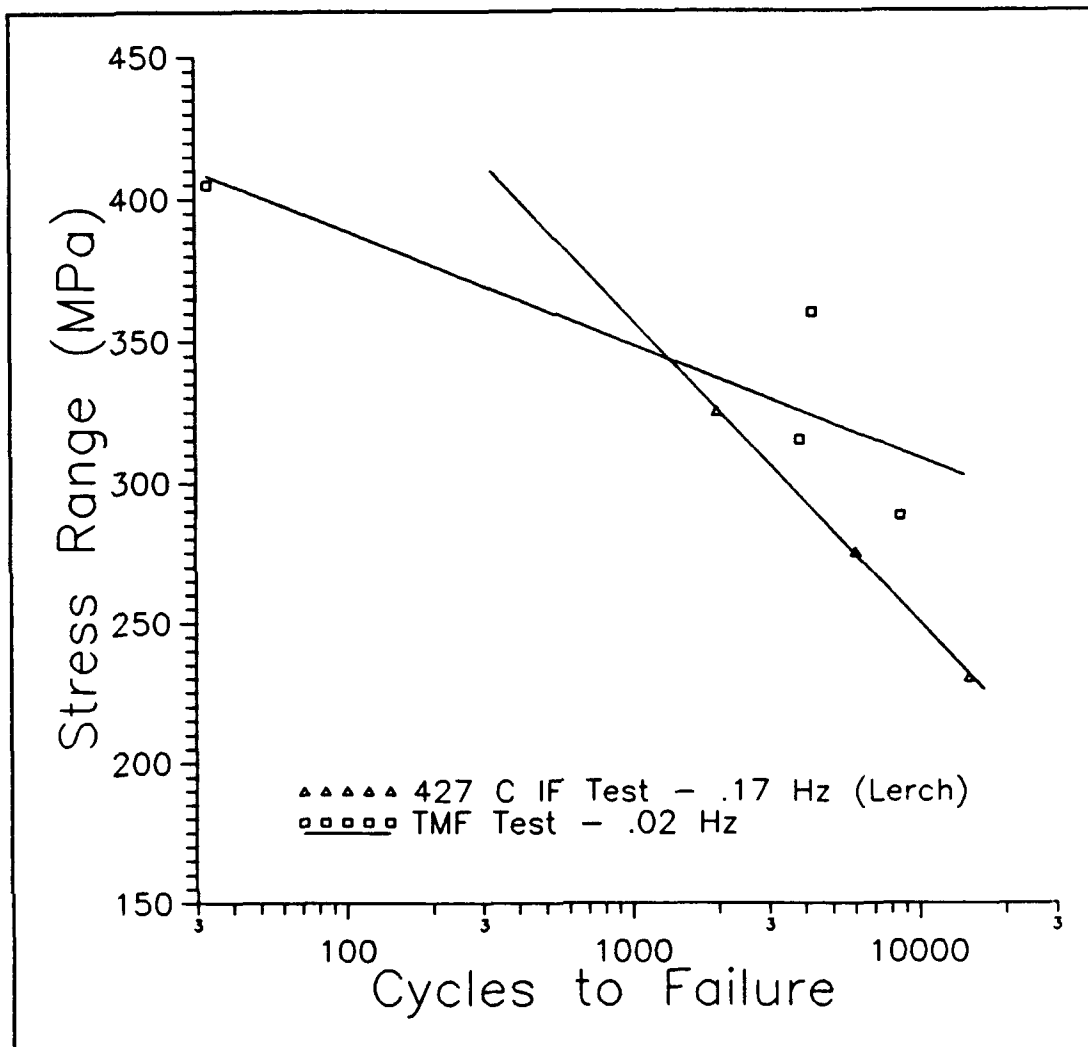
Figure 51. Fatigue Life Comparison between TMF Test and IF Test

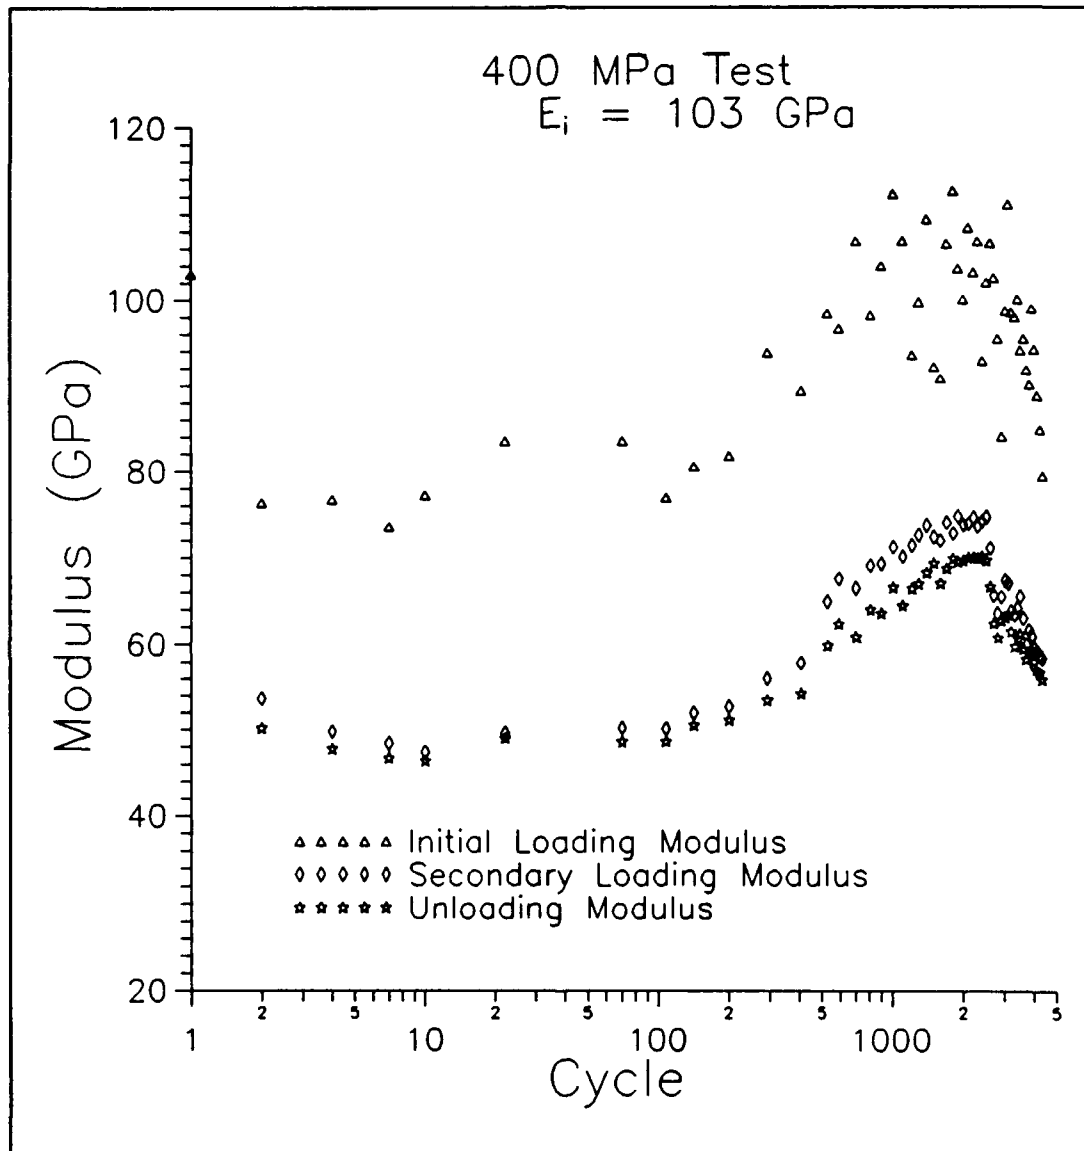
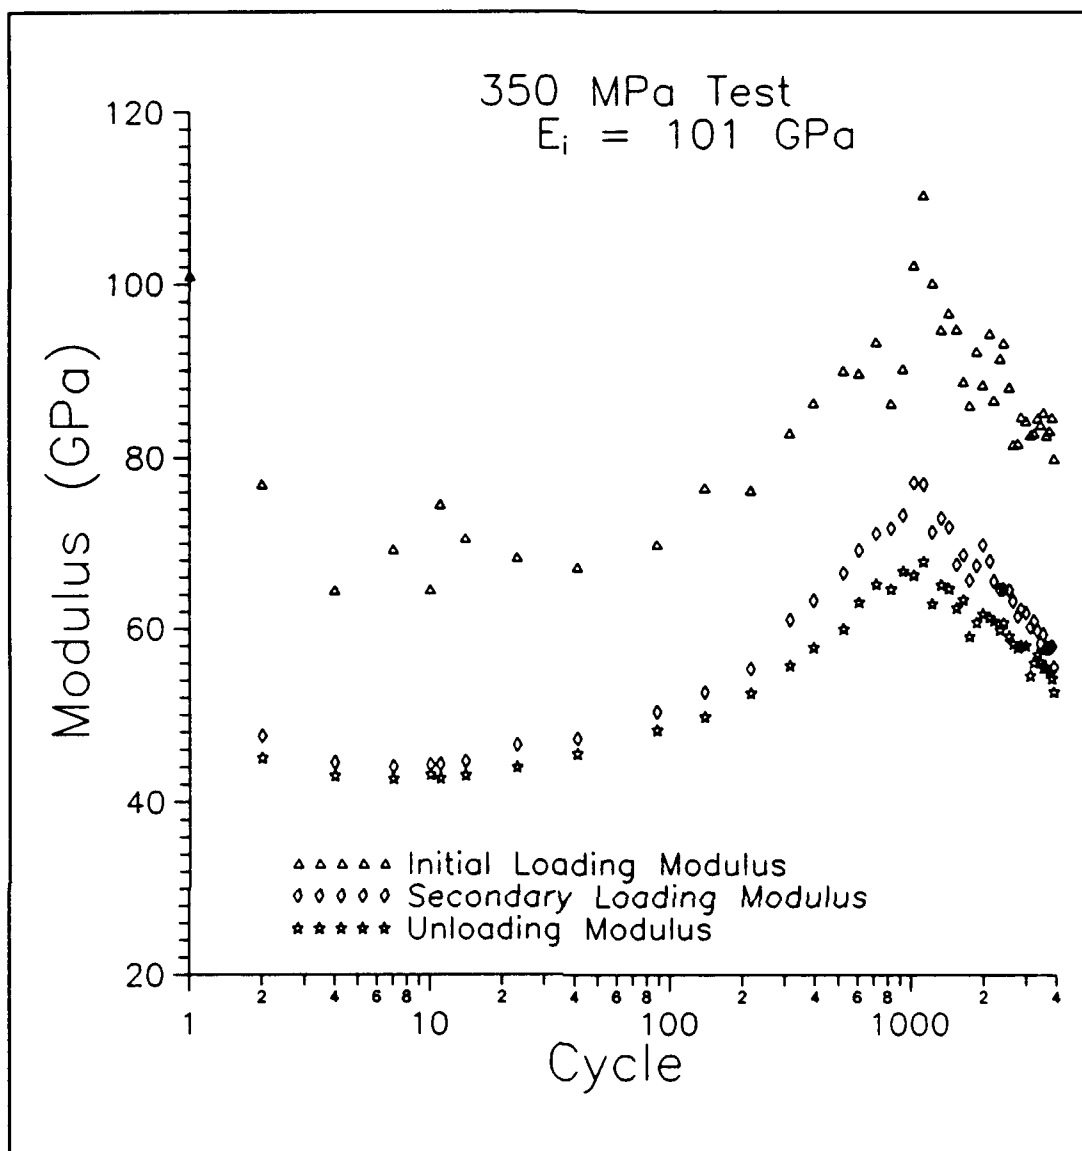
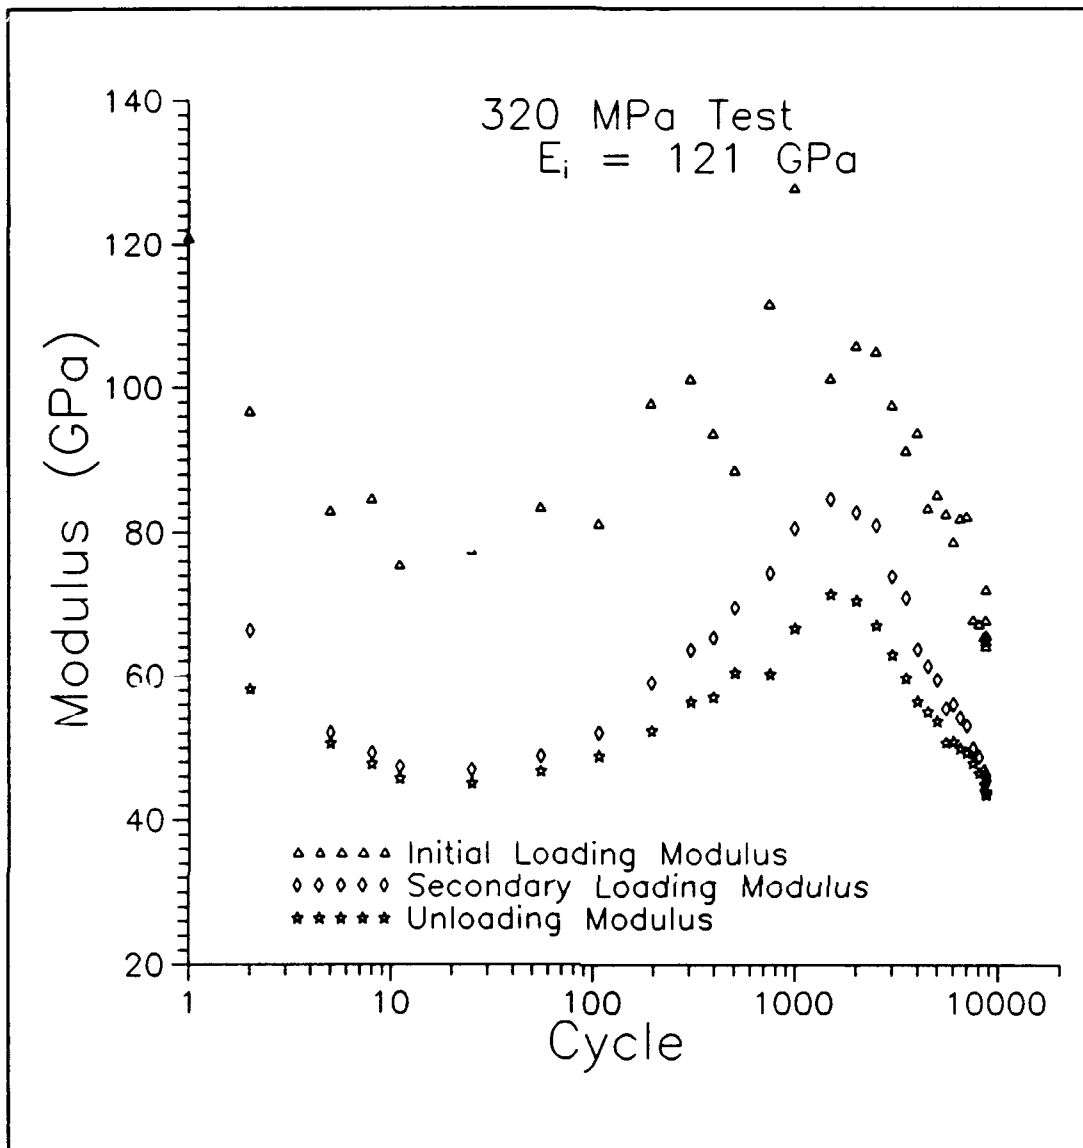
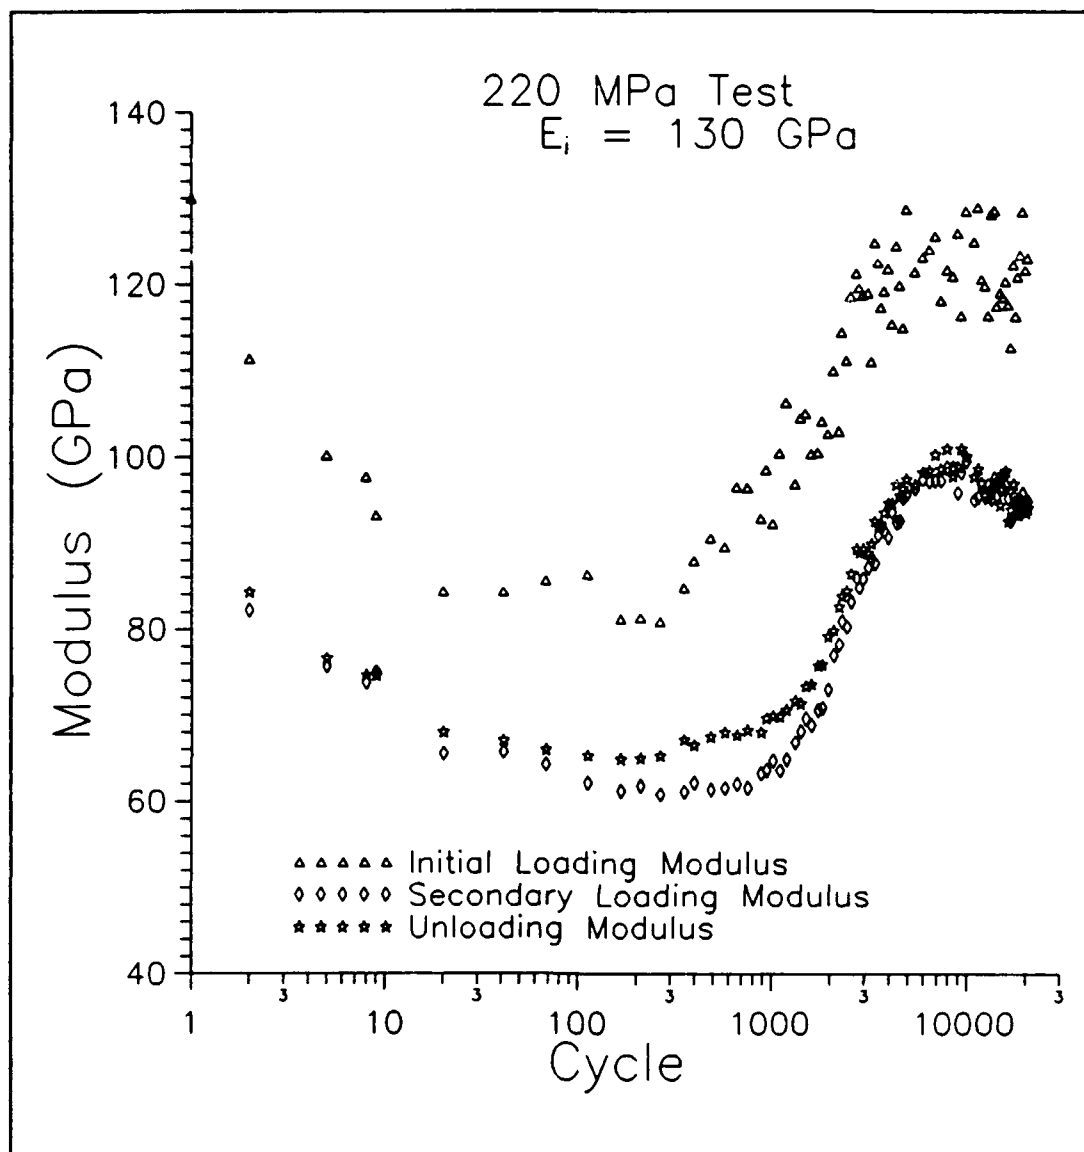
Figure 54. Modulii with Logarithmic Cycle Axis for 400 MPa Test

Figure 55. Moduli with Logarithmic Cycle Axis for 350 MPa Test

Figure 56. Moduli with Logarithmic Cycle Axis for 320 MPa Test

Figure 57. Moduli with Logarithmic Cycle Axis for 220 MPa Test

is a gradual decline in all three modulii until failure. Appendix A contains modulii plots on a logarithmic cycle axis which more clearly shows the early stiffness loss. The stiffness does not abruptly decline as failure approaches which indicates a sudden fracture. The 450 MPa test did not exhibit a gradual stiffness decrease after the hardening

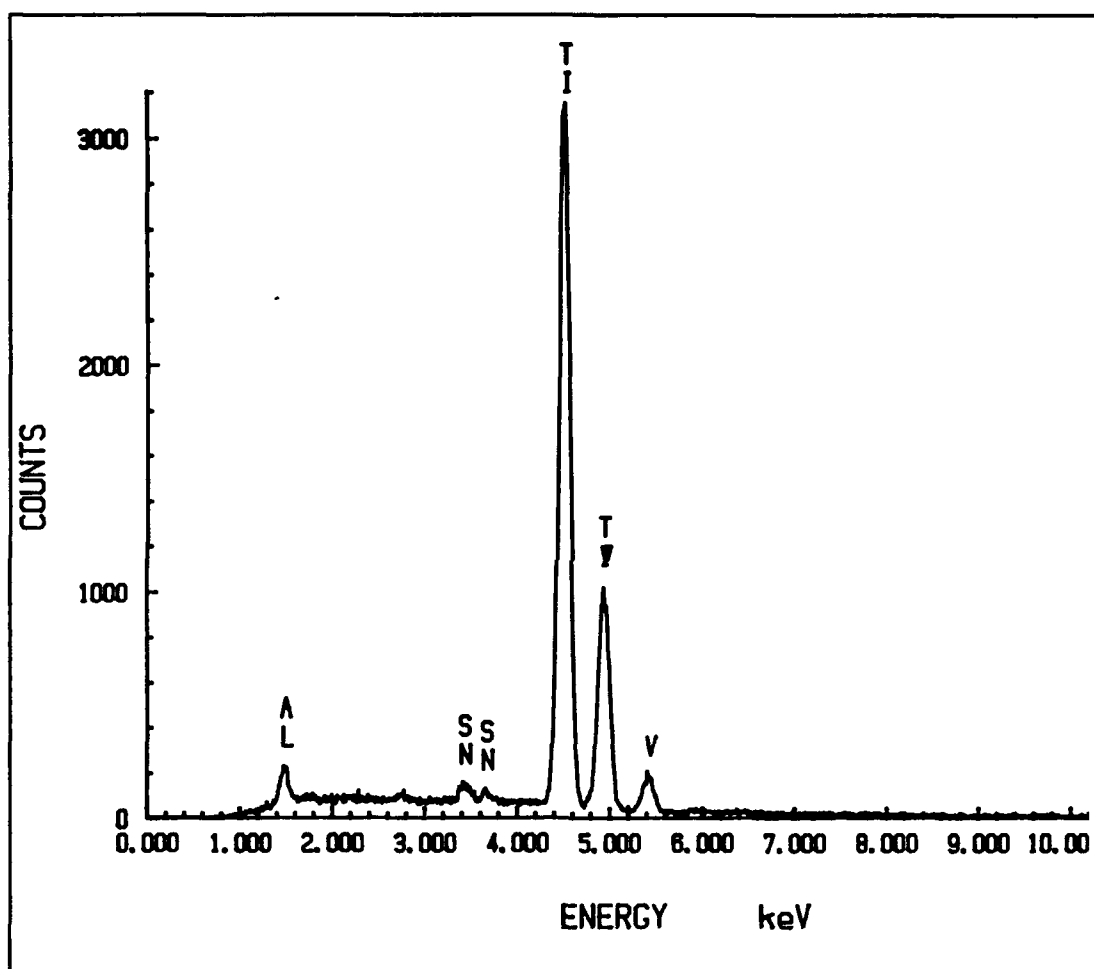
Figure 58. WDS Analysis of Uncycled Ti-15-3
